# SF6 Leak Contained with Belzona SF6-FIX Composite Repair

ID: 9849

**Industry:** Power  
**Application:** VPF-Valves, Pipes and Fittings  
**Substrate:** Carbon steel  
**Products:** Belzona 1982 (SuperWrap II), Belzona 7311

**Customer Location:** Ontario  
**Application Date:** February 2025

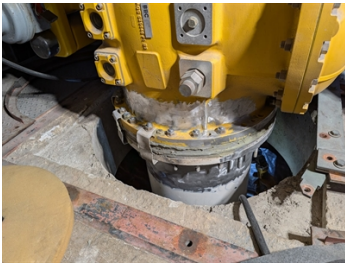
Application Area after surface preparation was completed

The surface was prepared using grinders, but because of the 90-degree angle on the flange, we couldn't reach all areas evenly. To help with bonding in the section that wasn't properly prepared, we applied Belzona 7311 with Belzona 9341 directly to that part of the flange face before putting the breathing membrane in place.

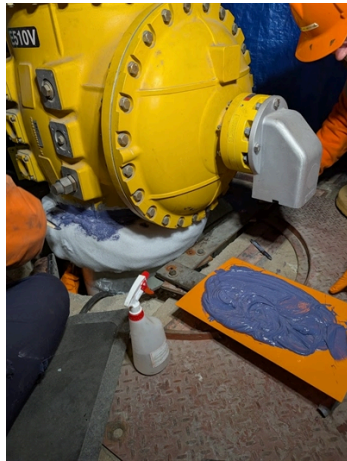
Belzona 7311 being applied onto the Breathing membrane

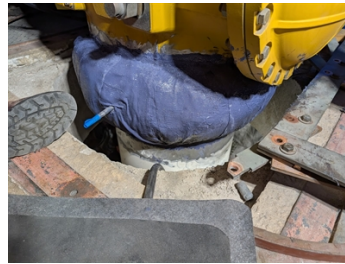
Belzona 7311 applied with reinforcement mesh

Next, we placed a membrane over the entire flange and applied Belzona 7311 with Belzona 9341 reinforcement tape. To complete the repair, we overwrapped the area with Belzona 1982 and Belzona 9371 reinforcement mesh, following the steps outlined in system leaflet GSS-14.

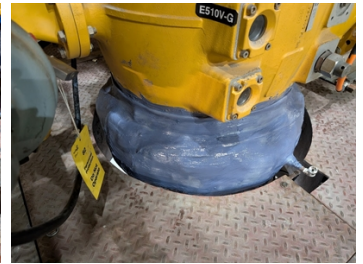
Completed Belzona SF6 leak repair system
