Sealing around welded pipework entry for chemical tank

ID: 9850

Industry: Pulp & Paper
Application: TCC-Tanks and Chemical Containment Areas
Substrate: Carbon steel
Products: Belzona 1161 (Super UW-Metal), Belzona 1391T

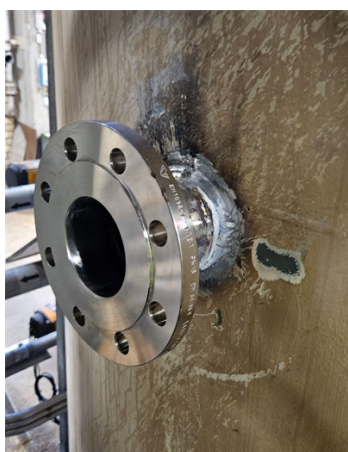
The new pipework is welded and in place

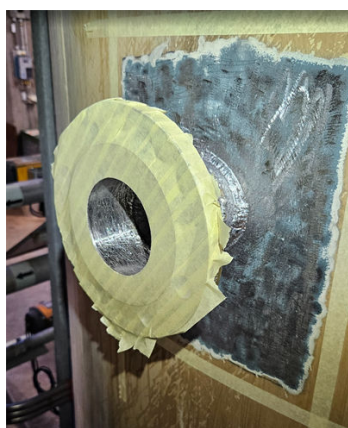
Masked edges and mechanical surface preparation

Mechanical surface preparation, Trowelling with Belzona 1161 on the new weld and transition, then 2 coats of Belzona 1391T

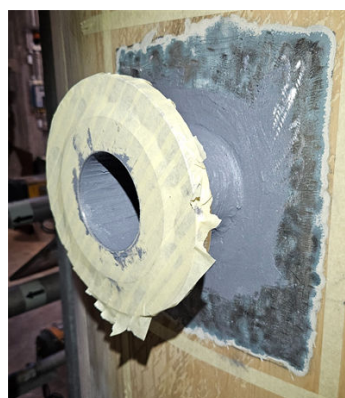
Grouted surfaces with Belzona 1161 to seal around the new weld
