# Belzona Shaft Repair on Commercial Mixer in Food Production Facility

ID: 9851

Industry: Food & Drink  
Application: MPT-Mechanical Power Transmission

Customer Location: Mississauga, Ontario  
Application Date: June 2025

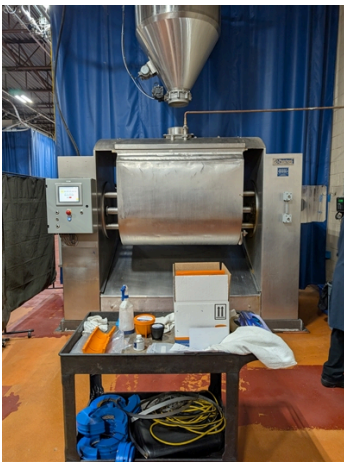
The Client, operating a Food Production facility in Mississauga, Ontario. Had a large scale, horizontal mixer experiencing advanced wear on several output shafts. Subsequently, the mechanical seals were unable to perform due to the damage, causing both product leakage and potential contamination. The equipment was a piece of legacy hardware that had previously been retrofitted and repaired using an unknown product.

Showcasing the piece of equipment

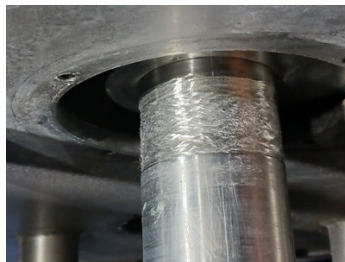
Completed surface prep of the damaged area

Surface prep was completed using a combination of Sanding Strips, Grinders, and Manual Filing tools.

The area was then taped off to prevent excess product from curing on the unaffected shaft areas.

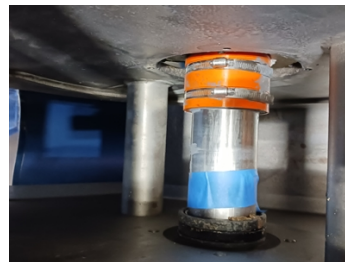
Repaired area using the Forming technique

This repair was completed using a custom printed 3D mold, coated with Belzona 9411 Release Agent

The Molds were then used in conjunction with Belzona 1311 to complete the repair using the proper Forming Technique.

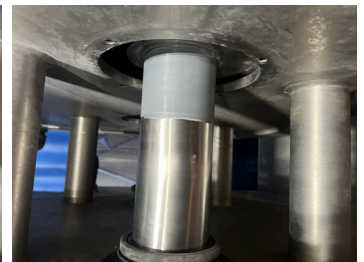
Completed repair area
