# Belzona Helps to Bring Chemicals Plant Back Online with Pump Refurbishment

ID: 9854

Application: CEP-Centrifugal Pumps

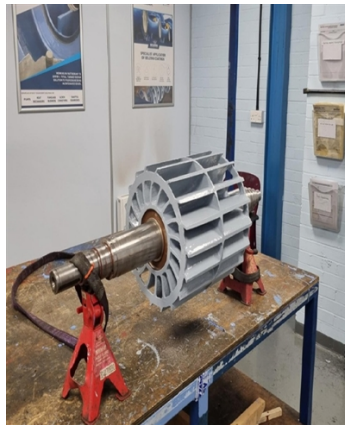
Before Coating

This pump was gritblasted to standard, any pitfilling was completed with Belzona 1111 and then two coats of Belzona 1341
