# Belzona 5811 Stops Corrosion in Waste Treatment System

**Industry:** Water / Wastewater  
**Application:** TCC-Tanks and Chemical Containment Areas  
**Substrate:** Carbon steel  
**Products:** Belzona 1111 (Super Metal), Belzona 5811 (Immersion Grade), Belzona 9111 (Cleaner Degreaser)

**Customer Location:** Southern Ohio Rest Area  
**Application Date:** September 1997

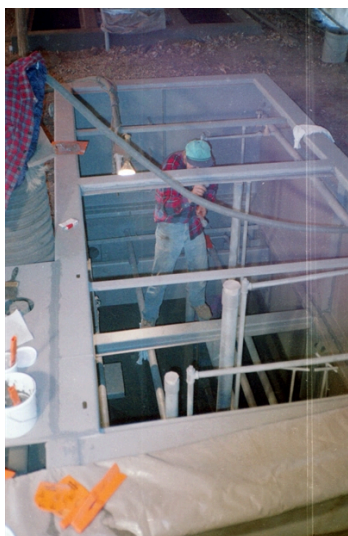
The State of Ohio tried a steel septic tank instead of concrete at one of their rest areas and were met with severe corrosion. Ohio specified Belzona 5811 (Immersion Grade) to coat the interior instead of replacing the tank with a concrete one.

Grit blasting was the preferred surface prep method followed by flooding with Belzona 9111 (Cleaner/Degreaser). Belzona 1111 (Super Metal) was used to stripe the weld seams followed by two 10-mil coats of Belzona 5811 (Immersion Grade)
