BELZONA REPAIRS HOLED NOZZLE ON GLYCOL PLANT

Application: VPF-Valves, Pipes and Fittings

Customer Location: Gas Processing Plant, UK

Application Date: August 2007

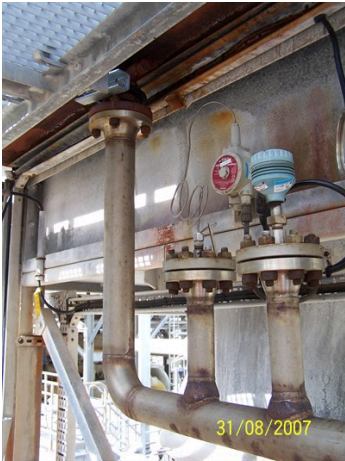
Corrosion had caused severe wastage of a nozzle which resulted in two holes breaking through.

* View of plant area , * View of one of the two holes in the nozzle , * View of the plates prior to bonding , * View after the plate bond and wrap was completed ,

Corroded and holed 3 inch diameter nozzle

Application was carried out in accordance with Belzona Know-How System Leflet VPF-11a. Plates were tailor made on site to completely encapsulate the nozzle. Once bonded, the whole nozzle was also wrapped.
