BELZONA REPAIRS HOLED NOZZLE ON GLYCOL PLANT

ID: 986

Customer Location: Gas Processing Plant, UK

Corroded and holed 3 inch diameter nozzle

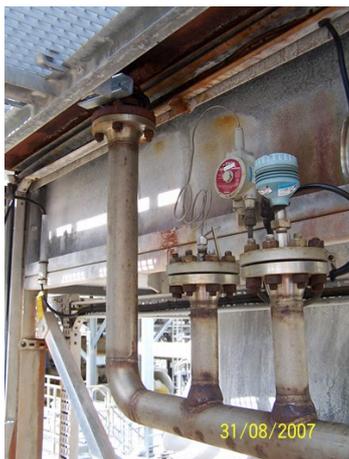
Corrosion had caused severe wastage of a nozzle which resulted in two holes breaking through.

* View of plant area , * View of one of the two holes in the nozzle , * View of the plates prior to bonding , * View after the plate bond and wrap was completed ,

Application was carried out in accordance with Belzona Know-How System Leflet VPF-11a. Plates were tailor made on site to completely encapsulate the nozzle. Once bonded, the whole nozzle was also wrapped.
