Elevator Buckets coated to save product build up

ID: 9868

Industry: Mining & Quarrying
Application: SHM-Solids Handling Machinery

Substrate: Carbon steel
Products: Belzona 1321 (Ceramic S-Metal), Belzona 1341 (Supermetalgilde), Belzona 9111 (Cleaner Degreaser)

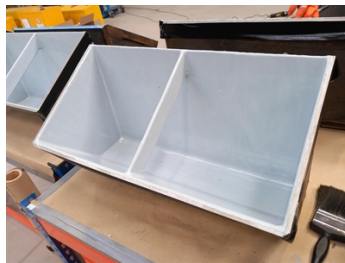
Buckets after removal from the Elevator shaft casings

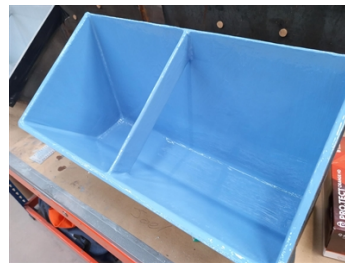
Showing blasted bucket with 1st coat of Belzona 1341 Supermetalgilde

Grit blasting to SA2.5 and 70 microns, in-house in Belzona's own state-of-the-art blast booths

Cleaned and degreased with Belzona 9111

1st coat as, per spec, applied of Belzona 1341

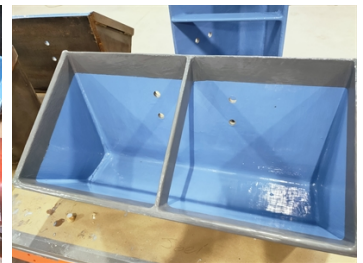
Showing 2nd coat of Belzona 1341 Supermetalgilde

Showing completed system, including leading edge protected by Belzona 1321 Ceramic S-Metal

2nd coat, as spec, applied of Belzona 1341

Leading edges coated with 2 x coats of Belzona 1321
