# Ball mill walls repaired with Belzona

ID: 9870

Industry: Mining & Quarrying  
Application: SHM-Solids Handling Machinery

Substrate: Carbon steel  
Products: Belzona 1121 (Super XL-Metal), Belzona 1511 (Super HT-Metal)

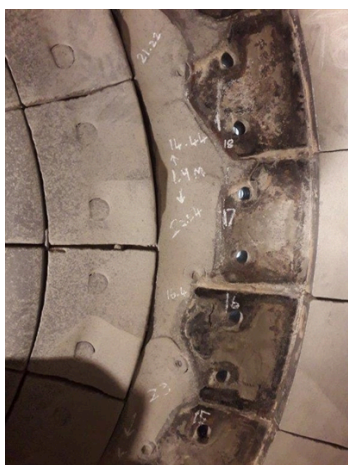
On removing the large wear plates inside a large Ball Mill, the internal surfaces of parts of the ball mill were showing severe wear, where the constant grinding had lead to dust getting through the gaps of the wear plates and eroding the actual surface of the ball mill walls and end faces

Showing large area of wear, once the wear plates have been removed

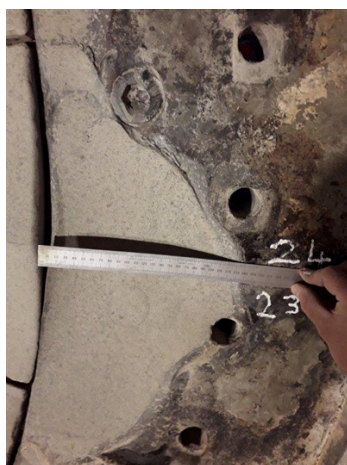
Showing depth of wear against Applications Team Straight edge

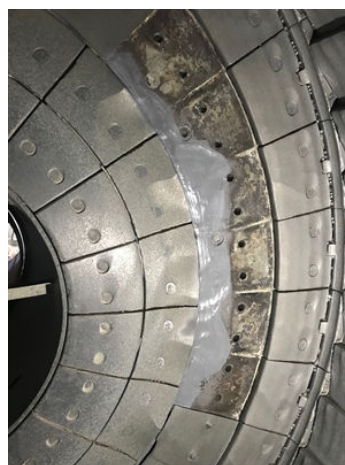
Same area as Photo 1, but now filled and ready for installation of wear plates

The target application areas were Grit Blasted to SA2.5 at 75 microns.

The Belzona 1511 was mixed to spec and was wetted out to the target areas using short bristled brushes

Belzona 1511 was applied using applicators to bring the work substrate back to the required profile.

A final application of Belzona 1121 was carried out and made ready for the installation of the new wear plates

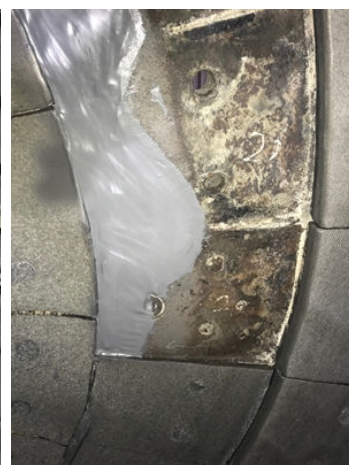
Same area as Photo 2, showing repair
