# Expansion joint improved to save damage to Fork Lifts

ID: 9871

Application: FPA-Floor Problem Areas

Application Date: January 2025

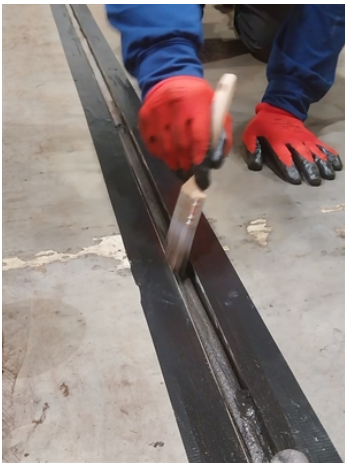
Joint taped and the application of Belzona 2911 Conditioner

Rake out all existing foams and other substances.

Vacuum joint to remove dust and debris

Install foam backer rod to a depth that of half the width of the joint

Apply Belzona 2911 conditioner as per spec

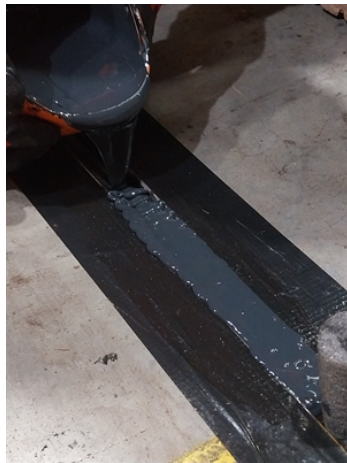
Pouring in the Belzona 2211 Hi-Build Elastomer

Mix and pour Belzona 2211 Hi-build to complete the finished application

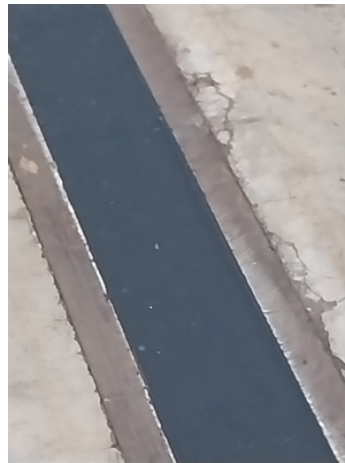
Expansion joint filled and tape removed

Allow to cure

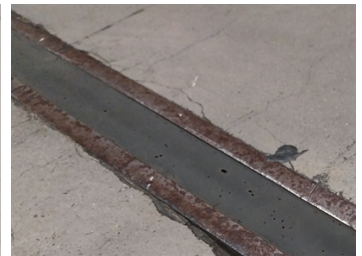
Trial Joint almost 12 months later

Fork Lift repair and maintenance costs are expected to reduce drastically, thanks to the Belzona application. Almost 1 year on, the joint has held perfectly well. The company are now considering carrying out the same repair to a further 4km+
