Boiler House External areas

ID: 9873

Industry: Buildings & Structures
Application: FPA-Floor Problem Areas
Substrate: Concrete
Products: Belzona 3131 (WG Membrane), Belzona 3931 (WG Membrane Conditioner), Belzona 4131 (Magma-Screed), Belzona 4911 (Magma TX Conditioner)

Customer Location: Stamford
Application Date: March 2025

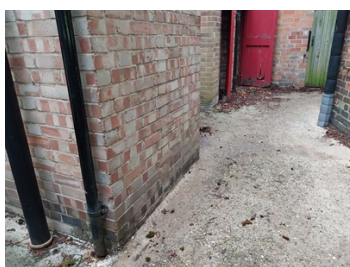
Showing areas of possible leakage through to the underground boiler house

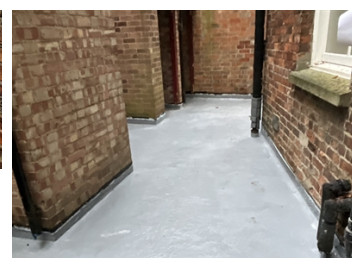
Completed with 2 x coats Belzona 3131
