Petrochemicals Hot Sulfur tank

ID: 9874

Industry: Oil & Gas
Application: TCC-Tanks and Chemical Containment Areas
Substrate: Carbon steel
Products: Belzona 1511 (Super HT-Metal), Belzona 1593

Customer Location: Oklahoma
Application Date: May 2025

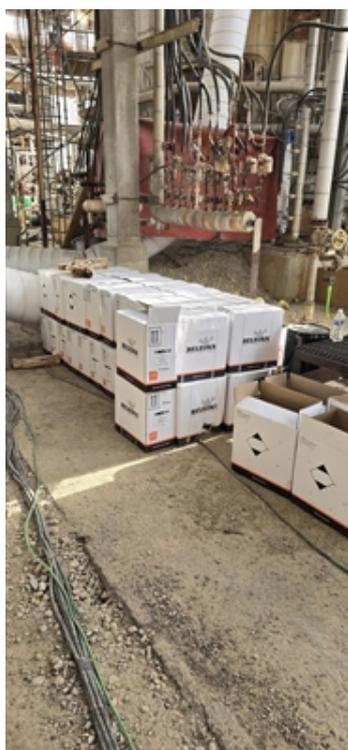
This is a high temperature sulphur tank. There was no protection on the inside of the strength for many many years. The tank had extreme corrosion and build up on the inside.

Inspector inspecting the tank for blast ISO 8501-1 Sa 2½ very thorough blast cleaning American Standard near white finish SSPC SP 10 Swedish Standard Sa 2½ SIS 05 5900 d) After blasting, metal surfaces should be coated before any oxidation

Belzona was selected over metal spray. The metal spray had too many harmful chemicals. The Belzona product had zero solvents
