Belzona repairs heavy traffic concrete floor

ID: 9878

Industry: General Industry
Application: FPA-Floor Problem Areas
Substrate: Concrete
Products: Belzona 4131 (Magma-Screed), Belzona 4911 (Magma TX Conditioner)

Customer Location: Mansfield
Application Date: July 2024

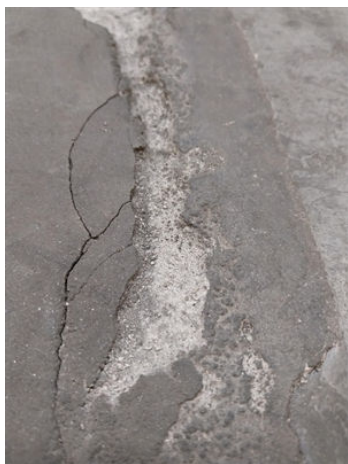
An area just inside the main roller door entrance, to a busy engineering works, experienced heavy traffic from forklifts, delivery vans and lorries. Over a period of time, the concrete slab gave up and started to disintegrate under the pressure of the traffic

Part of the main repair, a previous application failed after only 6 weeks. This was their fourth attempt at repairing this floor area

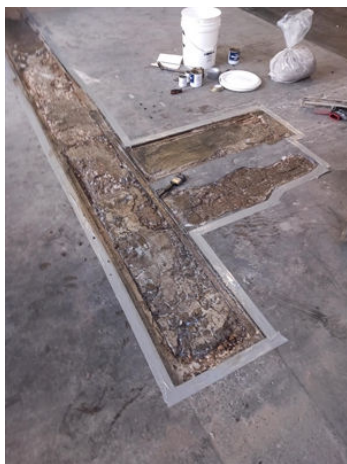
Old, loose concrete and failed repair, no further excavation required. Area coated with Belzona 4911 (TX Conditioner)

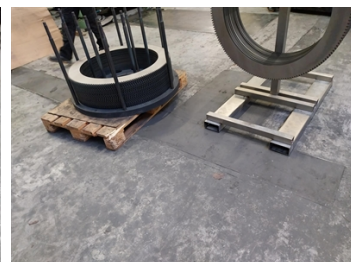
Shown here, in every day use, some 6 months on

After 5 failed attempts, the work was checked on after 6 months. No defects were found, apart from minor cracking to the concrete adjacent to the repair. The interface is still intact and the small cracks are in the parent concrete due to movement in the area. The

repair remains solid, flat, level and safe. The Engineer is now attracting a price from a Belzona Experienced Contractor to pursue all the other areas of damage
