# Belzona solution difficult racking issue

ID: 9879

Industry: General Industry  
Application: FPA-Floor Problem Areas  
Substrate: Concrete  
Products: Belzona 4111 (Magma-Quartz), Belzona 4911 (Magma TX Conditioner)

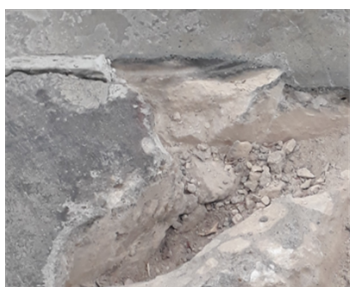
Floor failed where racking was due to be placed

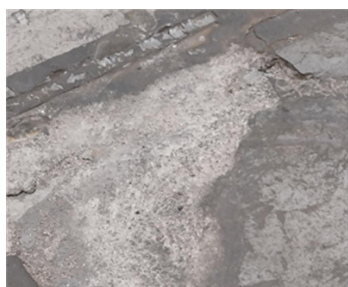
Opening up into the area of repair

The area was made rough, using cordless grinders with flap wheels and the area was vacuumed and cleaned

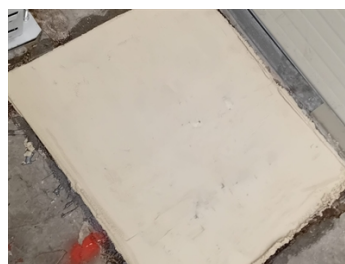
This shows the 500mm x 500mm pad constructed from Belzona 4111

Following this, the Belzona 4111 resins were mixed in a receptacle. The Belzona 4111 aggregate was added and mixed well

This was applied inside the frame and compressed/levelled using a finishing trowel.

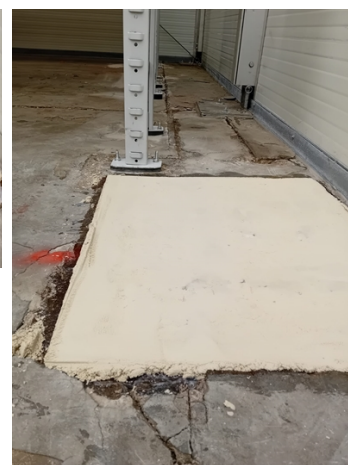
A further view of the new pad

Any unfinished external areas were also repaired using the system as above to leave a solid, level pad for the bolting of the racking to take place
