Expansion joint repaired using Belzona

ID: 9880

Industry: General Industry
Application: FPA-Floor Problem Areas
Substrate: Concrete
Products: Belzona 2211 (MP Hi-Build Elastomer), Belzona 2911 (Elastomer QD Conditioner)

Customer Location: Mansfield
Application Date: July 2024

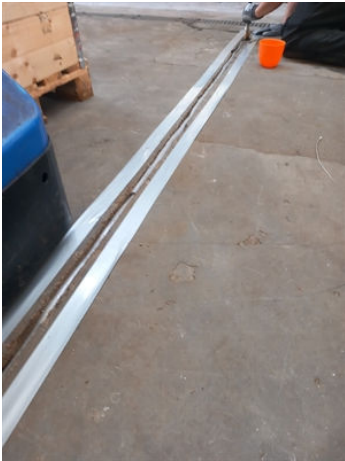
Area demarcated, prepared and cleaned

Remove all loose and friable material from the target area

Vacuum the joint to remove dust and debris

Tape the sides of the joint to help deliver a clean application line

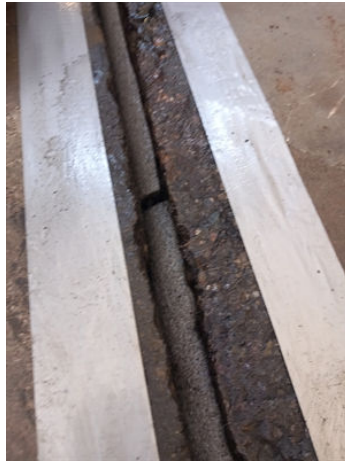
Foam Backer rod installed and Belzona 2911 (Elastomer QD Conditioner) applied

Offer in the foam backer rod do a depth of half the width of the joint

Apply a coat of Belzona 2911 (Elastomer QD Conditioner) with a short bristled brush

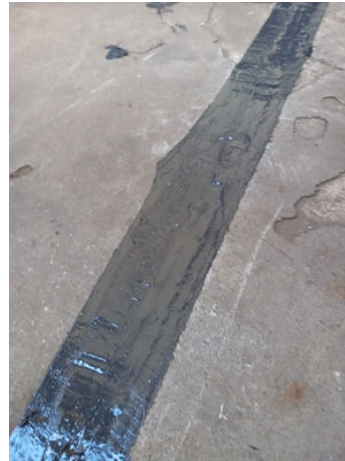
Expansion joint complete and tape removed

Mix the Belzona 2211 (MP Hi-Build Elastomer) in a mixing bowl and steadily pour the elastomer in, avoiding the inclusion of air bubbles

Use an applicator to smooth out the application and remove all tape

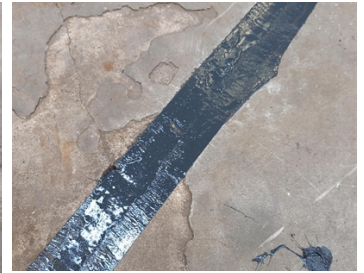
Problem solved with the Belzona 2211 (MP Hi-Build Elastomer) ensuring an even run for the hand pallet trucks
