BELZONA SOLUTIONS FOR REBUILDING & COATING LUBE COOLER/END COVER

ID: 9891

Industry:	Oil & Gas	Customer Location:	Abu Dhabi, United Arab Emirates
Application:	HEX-Heat Exchangers	Application Date:	March 2022
Substrate:	Bronze		
Products:	Belzona 1311 (Ceramic R-Metal),Belzona 1391 (Ceramic HT),Belzona 9111 (Cleaner Degreaser)

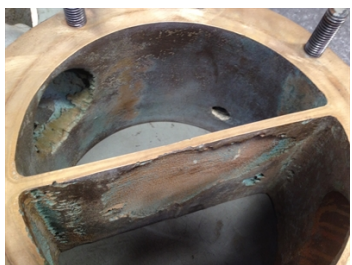
One of our offshore clients reported a case of corrosion affecting their heat exchanger (HEX) equipment. The root cause was identified as prolonged exposure to the highly humid and saline atmosphere typical of offshore environments. Such conditions significantly accelerate material degradation, leading to concerns regarding the structural integrity, safety, and long-term operational reliability of the equipment.

Degraded heat exchanger due to corrosion.

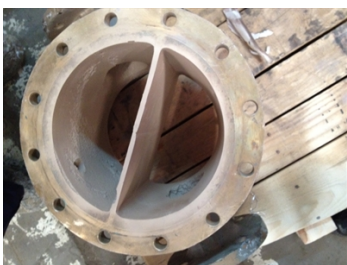
Surface preparation was done through grit blasting to SA 2.5 standard.

The application was carried out in accordance with Belzona Know-How System Leaflets HEX-1 and HEX-3, ensuring compliance with industry best practices for corrosion protection and extended equipment life. Surface preparation was done through grit blasting to SA 2.5 standard, followed by cleaning using Belzona 9111 (Cleaner Degreaser). Damaged areas were rebuilt with Belzona 1311 (Ceramic R-Metal), and the equipment was then coated with two layers of Belzona 1391 (Ceramic HT) for long-term protection.

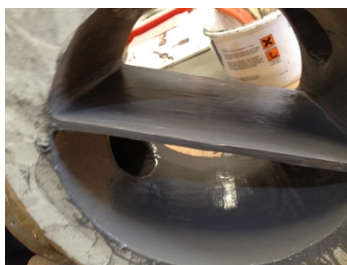
After cleaning the surface with Belzona 9111 (Cleaner Degreaser), Belzona 1311 (Ceramic R-Metal) was used to rebuild the damaged areas.

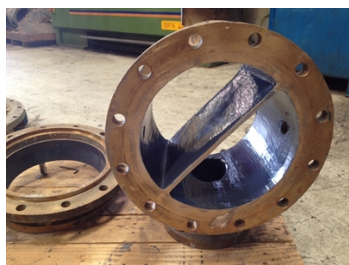
The equipment was subsequently coated with two layers of Belzona 1391(Ceramic HT) to ensure long-term protection.

During the inspection carried out in August 2024, the Belzona coating was observed to be in excellent condition, with no evidence

of discoloration, degradation, or loss of protection
