Floating roof repair.

Industry: Oil & Gas
Application: TCC-Tanks and Chemical Containment Areas
Substrate: Carbon steel
Products: Belzona 1212 Leak Sealing Kit, Belzona 9611 (ES-Metal)

Customer Location: Oklahoma city
Application Date: June 2025

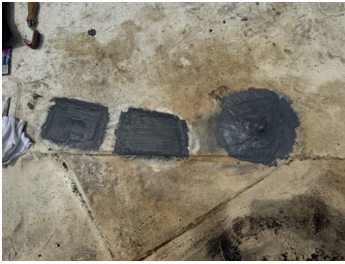
The floating roof developed a couple of corrosion holes on the plates.

Belzona 1212 Tank patches
view 1.

The area was prepped as best as possible by a hand metal brush, A Belzona 9611 emergency product was used to temporarily plug the hole.

After cured a kit with a mesh and Belzona 1212 was used to complete the repair.

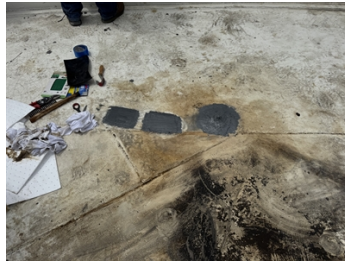
Belzona 1212 Tank patches
view 2

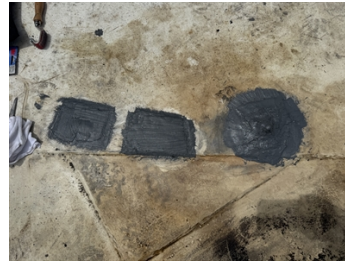
Belzona 1212 Tank patches
view 3

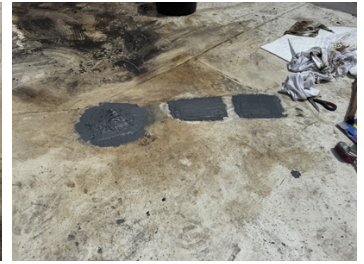
Belzona 1212 Tank patches
view 4
