# Belzona 1111 & 1321 Rebuild Underwater Generator Housing

**Industry:** General Industry  
**Application:** VPF-Valves, Pipes and Fittings  
**Substrate:** Other  
**Products:** Belzona 1111 (Super Metal), Belzona 1321 (Ceramic S-Metal)

**Customer Location:** Birmingham, AL  
**Application Date:** July 2025

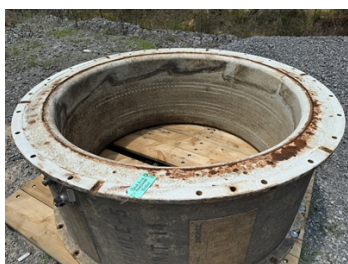
Generator Housing - Before

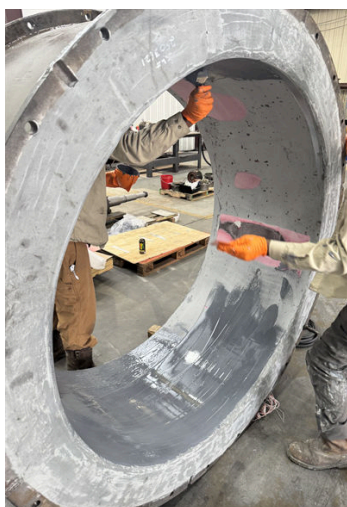
After removing the original fiberglass liner, it was re-seated into the housing. To machine to fit the fan blades that place within, Belzona 1111 was used to build up the housing to spec, and then was machined to fit.

The hydro-dam was unable to source or rebuild the underwater generator housing due to its age and design. Belzona offered an option to rebuild and restore the existing housing for the future. The fiberglass ring was cut out and all the wiring was replaced prior to Belzona. Once completed, a fiberglass ring was re-seated and glued in. There was still a minimum clearance that needed to be met, so we applied Belzona 1111 thick on the surface of the entire housing. A local machine shop turned the housing and machined down the Belzona 1111 to spec. Once finished, we applied two coats of Belzona 1321.

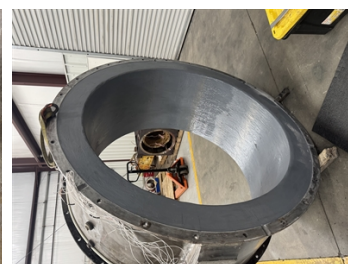
Final Coat of Belzona 1321 applied.
