Belzona 1111 & 1321 Rebuild Underwater Generator Housing

ID: 9898

Customer Location: Birmingham, AL

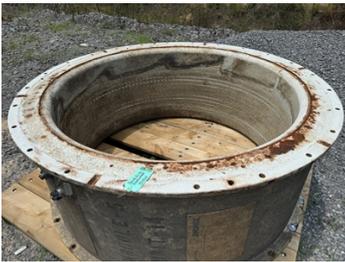
Generator Housing - Before

Our client is a motor manufacturer & repair shop that is industry wide. They received a fiberglass lined steel generator housing that is used submerged to process water through a hydro dam. The housing (1 of several) had been in service 25+ years and had started to see a leak into the motor area from the fiberglass internal ring. The design was no longer manufactured and could not be sourced, Belzona offered an option rebuild it.

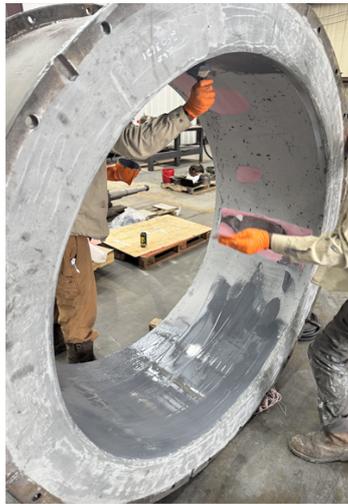
After removing the original fiberglass liner, it was re-seated into the housing. To machine to fit the fan blades that place within, Belzona 1111 was used to build up the housing to spec, and then was machined to fit.

The hydro-dam was unable to source or rebuild the underwater generator housing due to its age and design. Belzona offered an option to rebuild and restore the existing housing for the future. The fiberglass ring was cut out and all the wiring was replaced prior to Belzona. Once completed, a fiberglass ring was re-seated and glued in. There was still a minimum clearance that needed to be met, so we applied Belzona 1111 thick on the surface of the entire housing. A local machine shop turned the housing and machined down the Belzona 1111 to spec. Once finished, we applied two coats of Belzona 1321.

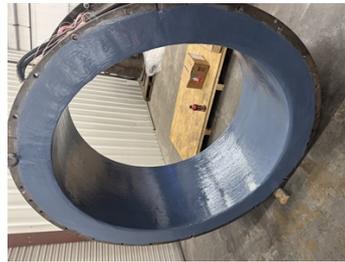
First coat of Belzona 1321 applied on top of the machined 1111.

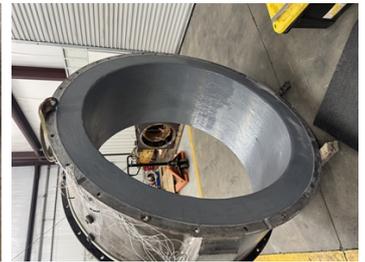
Final Coat of Belzona 1321 applied.
