# BELZONA REPAIRS TO LARGE RUBBER LINED VALVE

Customer Location: Power Station in Thailand.  
Application Date: May 1996

78-inch butterfly valve from cooling water system.

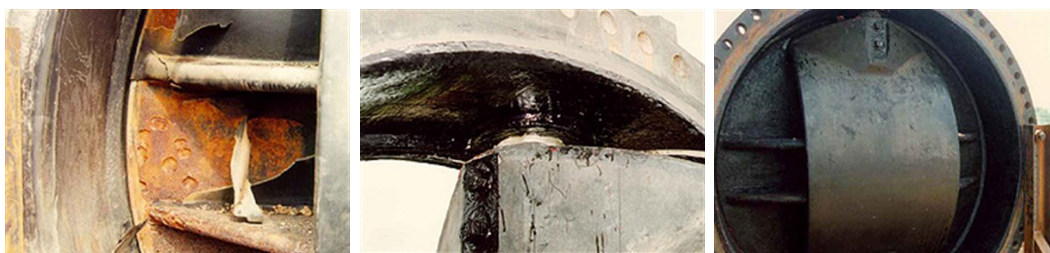
*Premature failure of vulcanised rubber lining allowed severe erosion-corrosion of underlying steel after just three months in service.*

- \* Condition of the valve after just three months in service ,
- \* Close-up of Belzona application showing encapsulation of bolts on valve disc ,
- \* Completed application. ,

Application was carried out in accordance with Belzona® system leaflets VPF-1 & 2 and GSS-1.

The use of Belzona Elastomers allowed repairs to be carried out quickly on-site thus minimising disruption to the plant.
