BELZONA® PREVENTS LEAKAGE IN A BALL MILL BEARING JOURNAL

ID: 990

Customer Location: Copper Mining Plant, Bulgaria

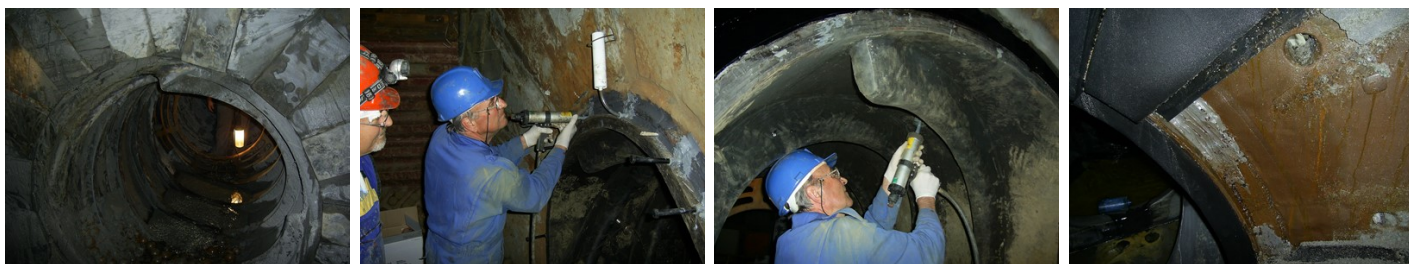
Photograph Descriptions

Wear on the housing due to ingress of the ore particles and water into the annular space between the insert (rubberized screw conveyor) and the housing (the journal of the mill). As a consequence a severe corrosion and abrasion occurred.

* Inside view of the Ball Mill Injection ports were created axial in the front of the insert with Belzona® 1221 and then Belzona® 1321 was injected to complete sealing of the annular gap Injection of Belzona® 1311 as irregular shimming along the insert length The applied Belzona materials still in perfect condition after 9 month and more than 5,500 working hours of the equipment ,

Application was carried out according modified versions of Belzona Know-How Leaflet GSS-9 and SOS-9. Belzona® 1321 was used to seal the annular gap at the inlet of the insert on the milling side and to prevent getting through of the milled particles between the insert and its housing (mill journal). Additionally approx. 2 kg of Belzona® 1311 were injected in each one of the certain locations along the insert length thus to create irregular shims and to support insert and to prevent its movement and vibrations.

Previous conventional repair by welding of the entire annular gap was not successful because of the heavy movement and vibrations so soon welds cracked. Belzona decision expanded the life of the equipment and was proven to be time and money saving. The regular inspection 9 months after completion of the first test repair with Belzona (resp. more than 5,500 working hours of the equipment) reviewed still perfect seal of the annular gap. Additionally two more mills were sealed, meantime with training of the customer maintenance staff. Since the mid of 2008 all similar repairs have been done by trained local staff.
