# Belzona Shaft Repair

ID: 9900

Application: MPT-Mechanical Power Transmission

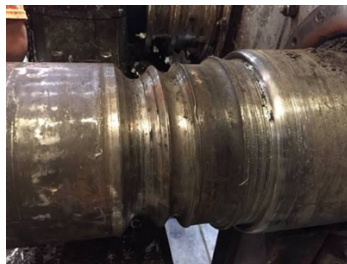
Bearing failure caused this shaft to wear in multiple places over 1/2 inch deep.

Worn Shaft from bearing failure Close up, getting ready to prepare the surface with a MBX Bristle Blaster.

Applying Belzona 1111 using a machined former to match the I.D. of the shaft.

Final result after two hours under heat to force cure we removed the former and used emory cloth to finish the surface to a smooth surface.

We first cleaned the shaft of any debris and oils. Taped the area to be repaired off and began prep with a MBX tool. Once the surface area was prepped we applied Belzona 9411 release agent to a former. Once the release agent dried we then applied Belzona 1111 to the shaft removed the excess and bolted the former to the shaft. We then applied heat with a halogen lamp for two hours and then removed the former.
