Steam Valve Raised Flange Face Rebuild

ID: 9903

Industry: Chemical & Petrochemical
Application: VPF-Valves, Pipes and Fittings
Substrate: Carbon steel
Products: Belzona 1511 (Super HT-Metal), Belzona 9111 (Cleaner Degreaser), Belzona 9411 (Release Agent)

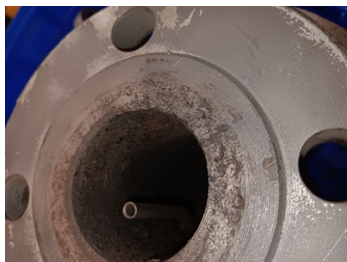
Flange face ready for preparation

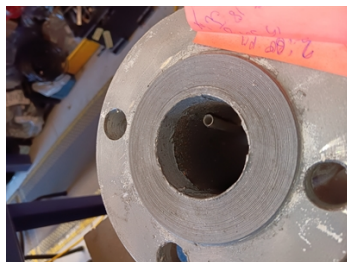
Flange face rebuilt using Belzona 1511, 9411 with customer supplied former.

Tooling used cabinet blaster, pencil grinder, machining files flat and round and also the Belzona product mixing tooling

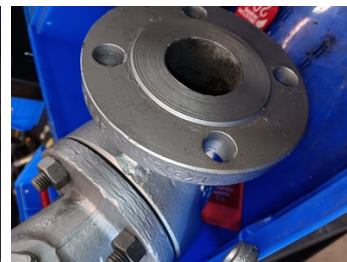
Rebuilt raised flange face complete and ready for installation and back into service.
