# Steam Valve Raised Flange Face Rebuild

ID: 9903

Industry: *Chemical & Petrochemical* Customer Location: *Ilderton Ontario*  
Application: *VPF-Valves, Pipes and Fittings* Application Date: *July 2025*  
Substrate: *Carbon steel*  
Products: *Belzona 1511 (Super HT-Metal), Belzona 9111 (Cleaner Degreaser), Belzona 9411 (Release Agent)*

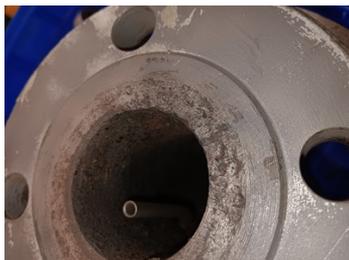
*Raised flange face was showing signs of corrosion and was leaking past the gasket.*

Flange face ready for preparation

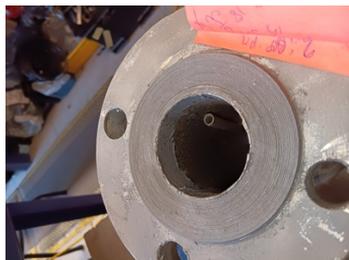
Flange face rebuilt using Belzona 1511, 9411 with customer supplied former.

Tooling used cabinet blaster, pencil grinder, machining files flat and round and also the Belzona product mixing tooling

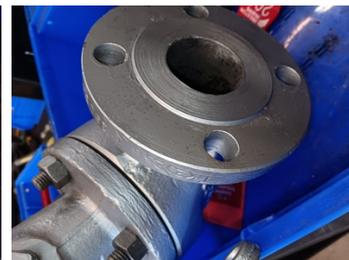
Rebuilt raised flange face complete and ready for installation and back into service.
