External repair to water tank

ID: 9905

Industry: Food & Drink
Application: TCC-Tanks and Chemical Containment Areas
Substrate: Other
Products: Belzona 1212

Customer Location: Newark
Application Date: May 2025

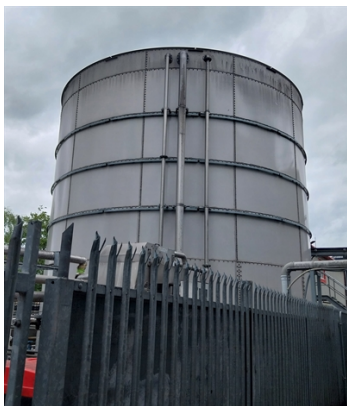
A constant leak meant that production water was escaping from a water tank in a large food processing plant. The lining is due to be replaced, but the engineering team needed to stem the leak that was costing them dearly in water top ups

The large water tank with compromised liner and through wall leak Showing a small, but costly leak toward the bottom of the tank Showing plate bonding to a live leak using Belzona 1212 Another angle of the repair

A mild steel patch was cut to size from 3mm sheet and was prepared using an angle grinder and cutting disc

The plate had the Belzona 1212 applied to it and then was pressed against the tank wall

A wooden sprag was employed to hold the plate in place until full cure
