Repair demo to Ferric Chloride Pipe

ID: 9906

Industry: Food & Drink
Application: VPF-Valves, Pipes and Fittings
Substrate: Stainless-steel
Products: Belzona 1212

Customer Location: Newark
Application Date: May 2025

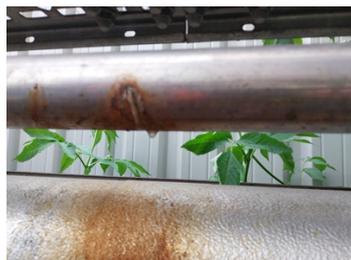
Showing one of many leaks to the main Ferric pipe range

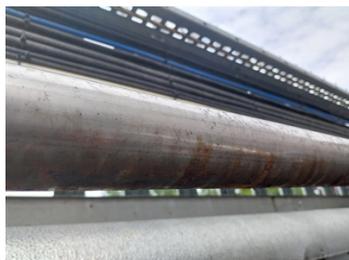
A general view of one leg of the pipe range

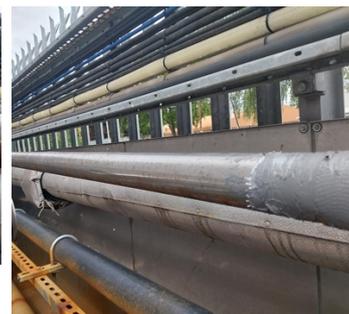
A repair effected by Belzona 1212 and Belzona 9341

Demo repair complete

The pipe was wire brushed and prepared using 80 grit emery paper.

The area was cleaned with Belzona 9111 cleaner degreaser

Belzona 1212 was mixed as per the Belzona 1212 IFU and wetted into the Belzona 9431 reinforcing sheet, previously measured out on a "dry wrap"

The loaded reinforcing sheet was wrapped fully, then 50% overlap until complete with a further full revolution
