# Belzona Seals Cracks in Concrete Sump

**Industry:** Chemical & Petrochemical  
**Application:** TCC-Tanks and Chemical Containment Areas  
**Substrate:** Concrete  
**Products:** Belzona 4111 (Magma-Quartz), Belzona 4911 (Magma TX Conditioner), Belzona 5815

**Customer Location:** Baytown, TX  
**Application Date:** September 2023

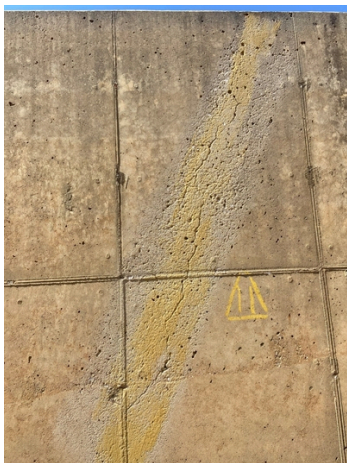
Crack in concrete along the wall of sump.

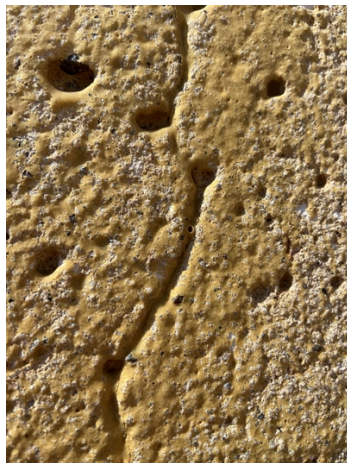
Close up photo of a defect in the sump wall.

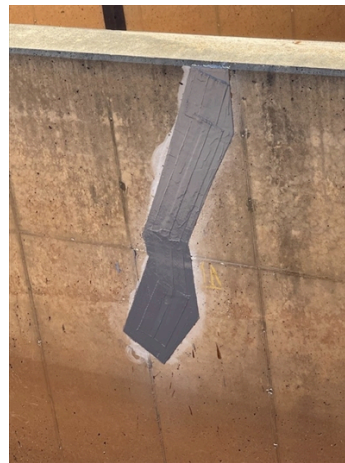
Belzona 5815 and 9371 crack repair on the application area.

1. Power tool prep with grinders to vee out the cracks and prepare the concrete surface.
2. Apply Belzona 4911 conditioner
3. Apply Belzona 4111 to pit fill/rebuild lost concrete
4. Apply Belzona 5815 and 9371 to patch over the cracks

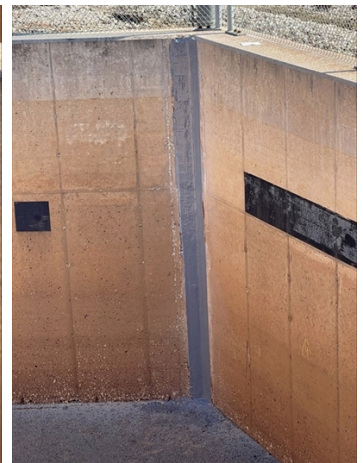
Floor to wall joint crack repair in grey, and existing previous Belzona crack repair in black still in good condition.
