# Belzona Protects Chiller at a Large Commercial Building Downtown Houston TX

ID: 9909

Application: HEX-Heat Exchangers

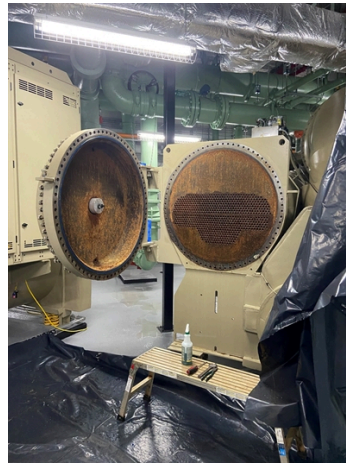
Client has 4 chillers to create air conditioning for their roughly 50 story building in downtown Houston. The building was built within the last 10 years, and has seen heavy corrosion/erosion on the tube sheet from the city water. When they complete their annual maintenance checks they have seen it get worse each year. They have tried different water treatment options but have not had success in limiting corrosion to metal on tube sheet, water box, and end covers. The onsite engineering team championed using Belzona to the building developer to provide a long-term corrosion protection solution.

Chiller current condition opposite side

1. Chiller was opened, drained, and dried with fans.
2. Containments were built with sheets of poly around both ends, making it air tight containment.
3. Tubes were corked.
4. Abrasive blasting was completed to achieve SSPC SP10 profile on the application area.
5. Belzona 1121 was applied to pit fill and rebuild lost metal where needed.
6. Belzona 1321 was applied in a two-coat system, grey first then blue topcoat.
7. Product allowed to cure and put back in service.

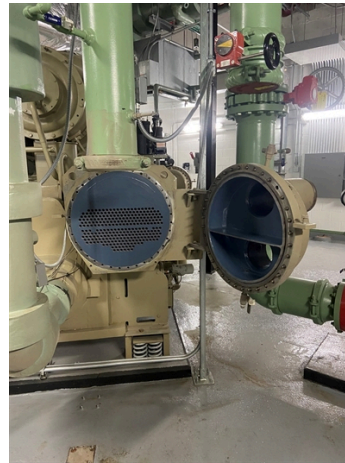
Chiller completed application one side

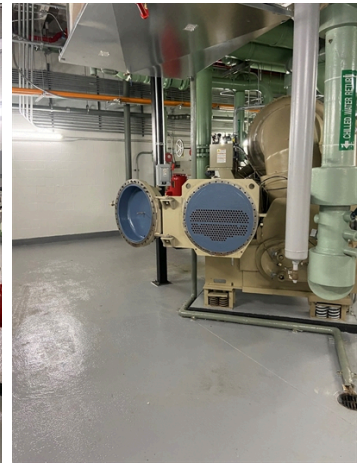
Chiller completed application
