# Belzona Protects Sulfuric Acid Containment

**Industry:** Chemical & Petrochemical  
**Application:** TCC-Tanks and Chemical Containment Areas  
**Substrate:** Concrete  
**Products:** Belzona 4124 (Bulkfill), Belzona 4311 (Magma CR1), Belzona 5811 (Immersion Grade)

**Customer Location:** Conroe, TX  
**Application Date:** October 2023

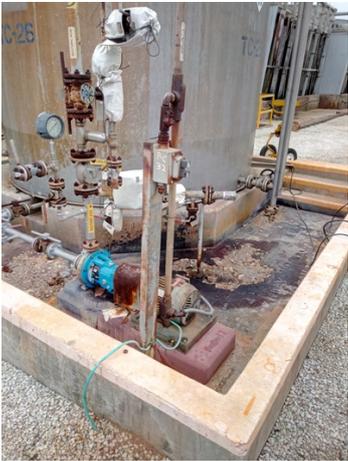
Client has a concrete sulfuric acid containment near a cooling tower. The concrete has damage from spills / leaks of the 98% sulfuric acid into the non coated concrete and from always being wet in TX humidity & nearby cooling tower mist. The acid and moisture have caused cracks & spalling in the concrete over time. The customer wanted a long term solution to protect the concrete.

Acid containment with damage in concrete before application

1. A containment was built around the concrete containment.
2. The concrete was vapor blasted to roughen the concrete and create an optimal profile to bond to.
3. Belzona 4124 was used to rebuild lost concrete on the containment floor in the damaged areas.
4. First coat of Belzona 5811 was applied with nonskid to create a non-slip surface.

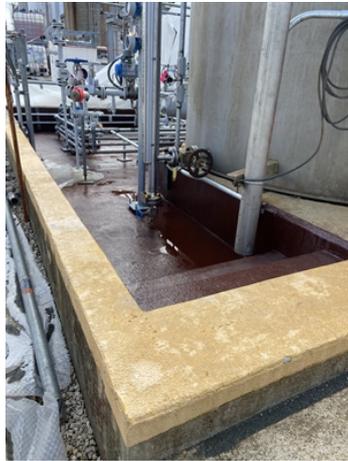
Belzona 4311 applied into containment

5.☑Belzona 4311 was applied as the top coat for long term protection against chemical attack.

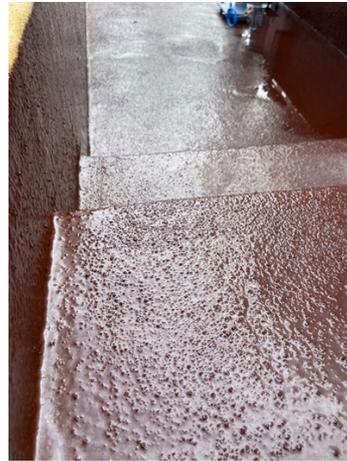
Close up on coating with non skid aggregate

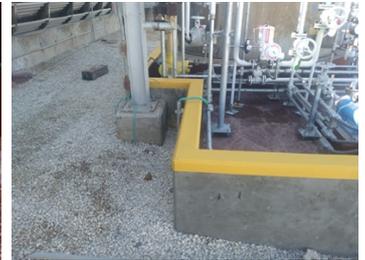
About 1.5 years after install we completed a visual inspection of the coating and it was still in good condition.

At the 1.5 year follow up inspection the coating was in excellent condition. The area showed no spalling, cracking, or delamination of coating. The customer is happy. If a facility has a spill of acid into ground soil it can cause extreme fines and shutdown of the facility. This Belzona repair helps protect from that happening.
