Belzona 1121 Pit Fills Skid

ID: 9913

Industry: Oil & Gas
Application: FPA-Floor Problem Areas
Substrate: Carbon steel
Products: Belzona 1121 (Super XL-Metal), Belzona 9111 (Cleaner Degreaser)

Customer Location: Houston, TX
Application Date: August 2023

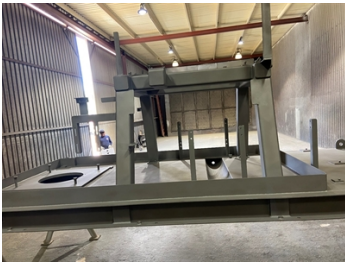
Skid overview

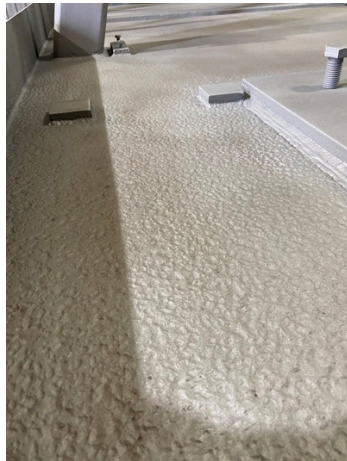
Skid after abrasive blasting

1. Abrasive blast was used for surface preparation (SSPC-SP10)
2. Substrate was wiped clean with Belzona 9111 and let dry.
3. Belzona 1121 25kg kit was mixed and applied to the application area. A Belzona applicator was used to trowel on product and fill in pitting.

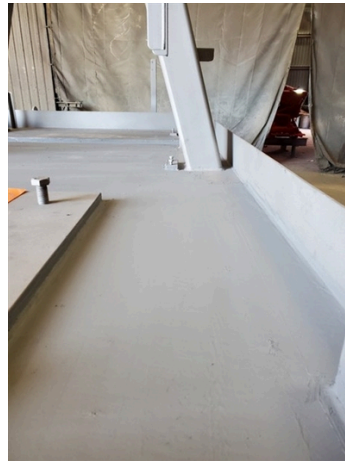
Belzona 1121 applied and smoothed over pitting

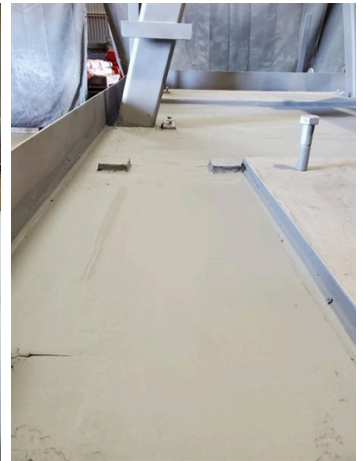
Belzona 1121 applied and smoothed over pitting
