Belzona Rebuilds & Protects Chiller Head Cover

Application: HEX-Heat Exchangers

Substrate: Carbon steel

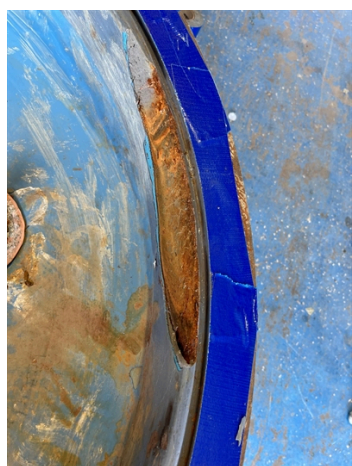
Client was completing the annual maintenance on their chillers and noticed damage on the end covers. The asset was previously lined by a competitor to Belzona, and it was failing around the edge. A chunk of the end cover came off which caused concerns. The previous coating was delaminating, metal loss was occurring and made it unsafe to put back into service.

Defect area

1. Power tool prep to remove loose adhered coating and roughen up metal (SSPC-SP11)
2. Substrate was wiped clean with Belzona 9111 and let dry.
3. Belzona 1121 was applied to rebuild lost metal.
4. Belzona 1321 applied in a two coat system

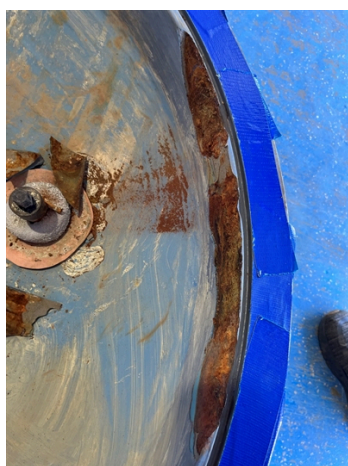
Defect area #2

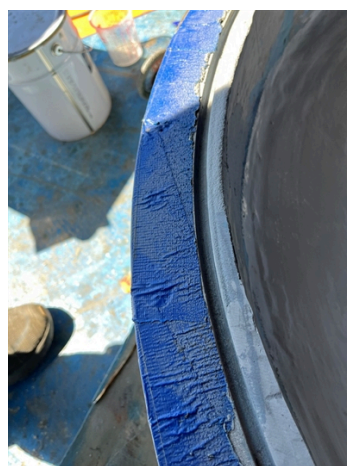
Rebuilt edge

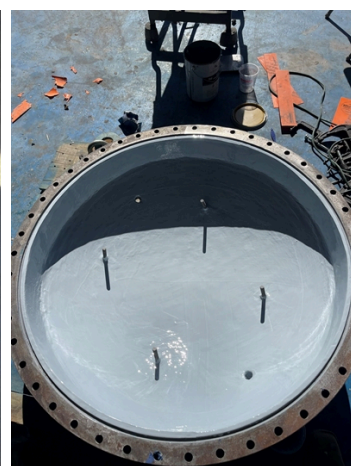
Final result with two coat system of Belzona 1321
