# Belzona Composite Wrap on Discharge Pipe and Internal Liner on Sump

ID: 9915

Application: TCC-Tanks and Chemical Containment Areas

Substrate: Carbon steel

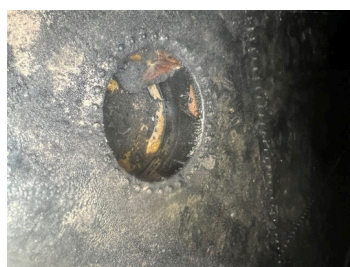
Client has a small sump at the bottom of a large holding tank. The tank was previously lined with a polyurea coating. The sump has a 7" OD discharge pipe extending out of it to drain materials where needed. The sump internal liner was failing, and the pipe was externally and internally seeing corrosion. This customer passes well completion fluids in these tanks and it was eating away at the previous polyurea liner over time.

Before image of the sump with existing polyurea liner on it. Internal view.

1. Abrasive blasting surface preparation (SSPC-SP10)
2. Apply Belzona 1121 to pit fill defects on pipe and sump
3. Apply 2 wrap / 4-layer system of 4151 & 9371 to the pipe externally
4. Apply internal liner to sump and pipe with Belzona 1321

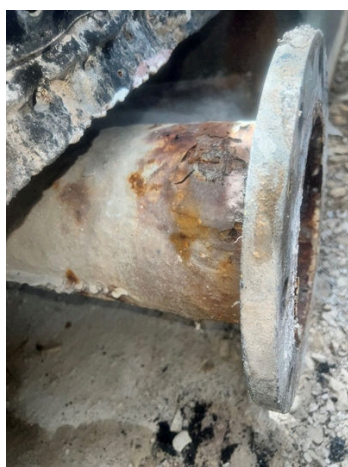
Before image of the discharge pipe coming off of the sump. External view.

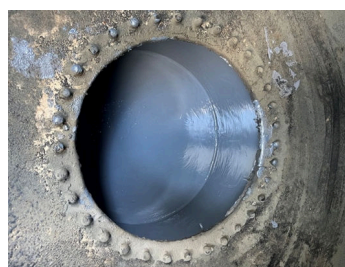
Internal view of sump after Belzona 1321 was applied.

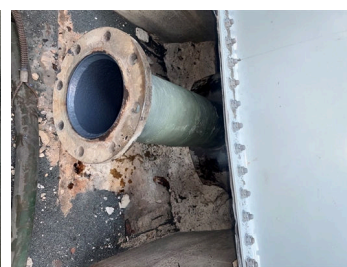
External view of pipe after Belzona composite wrap was applied.
