Belzona Composite Wrap on Discharge Pipe and Internal Liner on Sump

ID: 9915

Customer Location: Galveston, TX
Application Date: September 2023

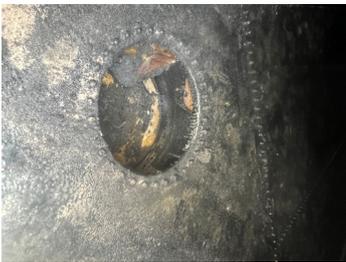
Before image of the sump with existing polyurea liner on it. Internal view.

1. Abrasive blasting surface preparation (SSPC-SP10)
2. Apply Belzona 1121 to pit fill defects on pipe and sump
3. Apply 2 wrap / 4-layer system of 4151 & 9371 to the pipe externally
4. Apply internal liner to sump and pipe with Belzona 1321

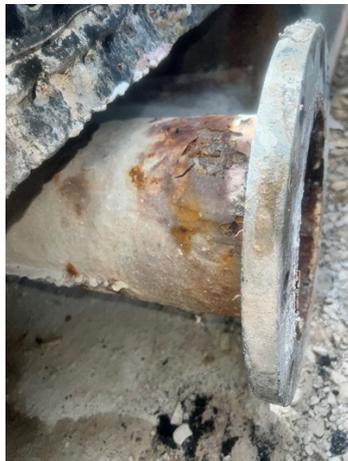
Before image of the discharge pipe coming off of the sump. External view.

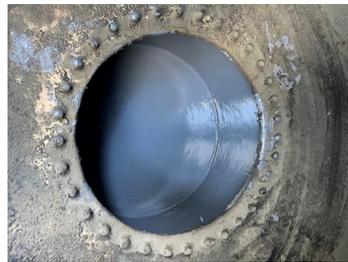
Internal view of sump after Belzona 1321 was applied.

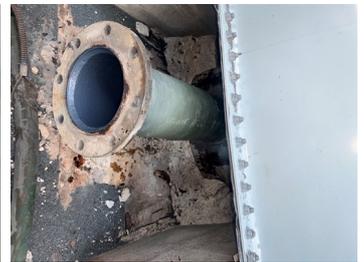
External view of pipe after Belzona composite wrap was applied.
