Belzona opens the door

ID: 9919

Application: ENC-Engines and Casings

Application Date: July 2025

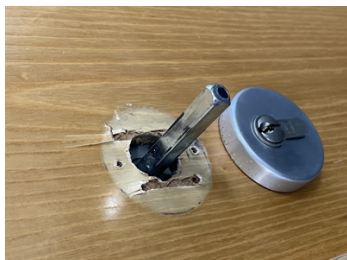
The damaged door

The screws on the door handle had pulled and ripped the wood, due to finance team's enthusiasm to get to work. Having a screw loose, or more than one, is not good for such a critical operating area, so it was important for the site facilities team to respond quickly to ensure the internal customer was happy and the facilities team would be paid at the end of the month.
