# Belzona repairs Community changing room container

ID: 9920

**Industry:** Local Authorities & Municipalities  
**Application:** WPA-Wall Problem Areas  
**Substrate:** Aluminum  
**Products:** Belzona 3121 (MR7)

**Customer Location:** Nottingham  
**Application Date:** March 2025

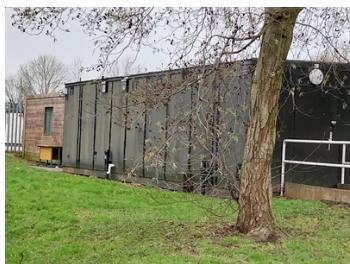
A community Junior football team were using a modified container as their main changing and shower facility. The roof and walls were found to be letting in rain water and needed to be sealed

The container on first inspection

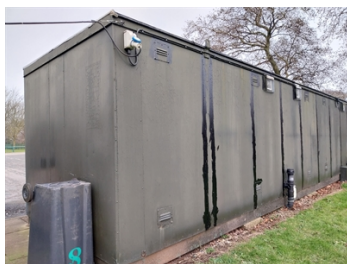
Showing previously failed repairs

High pressure wash all joints and remove as much of the previous failed repair as possible

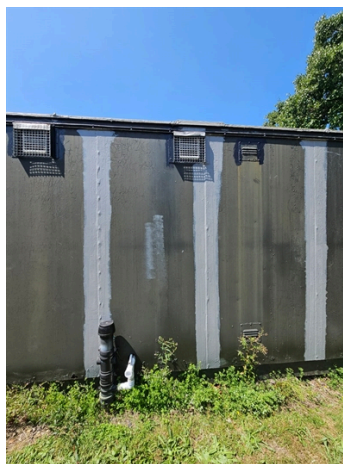
Belzona repairs carried out by one of the client's contractors

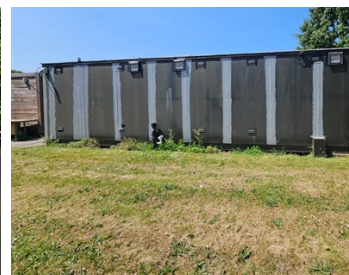
Container walls and roof resealed with Belzona 3121

Wire brush all target areas to remove any loose, rusty and dirty particles

Clean down all target area with Belzona 9111

Mix and apply 2 x coats of Belzona 3121 incorporating Belzona 9331 reinforcing sheet to all target areas on walls and roof
