# Internal Rehabilitation of Heat Exchanger Using Belzona 1111 & 1321

**Application:** HEX-Heat Exchangers

**Substrate:** Carbon steel

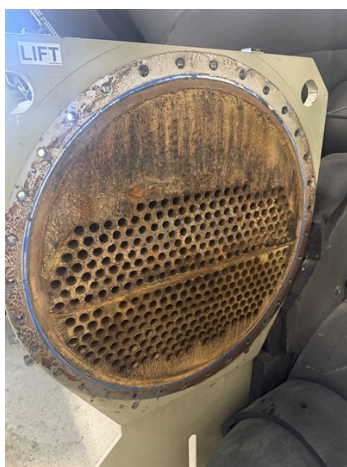
Initial condition of the heat exchanger showing severe corrosion and rust accumulation on the tube sheet surface.

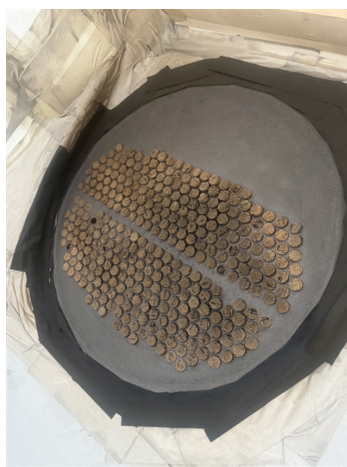
Surface after abrasive blasting, showing a clean and profiled tube sheet ready for application. Tubes protected using corks.

The internal surfaces were abrasive blasted to obtain a clean and rough surface with an anchor profile of approximately 3 mils. A chloride contamination test was performed after blasting to confirm surface suitability. Degreasing was then carried out using Belzona 9111. Areas with visible metal loss or damage were rebuilt using Belzona 1111 (Super Metal). After the rebuilding process, Belzona 1321 (Ceramic S-Metal) was applied in two coats, grey followed by blue, to ensure full coverage and long-term corrosion protection.

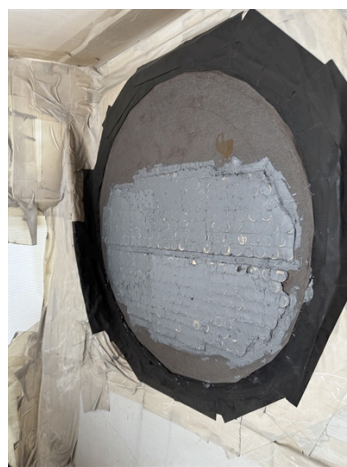
Rebuilding damaged areas using Belzona 1111 (Super Metal) to restore metal loss and ensure structural integrity.
