# BELZONA ROOF APPLICATION STILL WATERTIGHT 20 YEARS ON

ID: 993

Industry: *Buildings & Structures*  
 Application: *RPA-Roof Problem Areas*  
 Substrate: *Exposed aggregate concrete*  
 Products: *\* Belzona® 3111 (Flexible Membrane) ,*

Customer Location: *Auto manufacturer, Wentzville, MO*  
 Application Date: *October 1988*

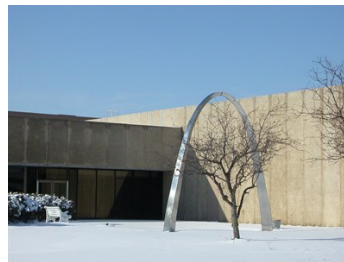
*Water was leaking in, staining wallpaper, ceiling tile and carpet causing an obvious unsightly mess.*

- \* Belzona® 3911 being applied ,
- \* Belzona® 3111 application ,
- \* Follow up picture February 2008 ,

Parapet wall joints on visitors center leaking. Previous attempts with silicone sealant failed quickly.

Application carried out in accordance with the Belzona Know-How System Leaflet RPA-10.

Labor costs of applying silicone sealant, which did not work, far exceeded the cost of the Belzona application. 20 years later, no leaks!
