Belzona Repairs Pillow Block on Marine Winch

ID: 9930

Industry: *Marine*
Application: *SOS-Ships and Offshore Structures*

Substrate: *Stainless-steel*
Products: *Belzona 1161 (Super UW-Metal), Belzona 9111 (Cleaner Degreaser)*

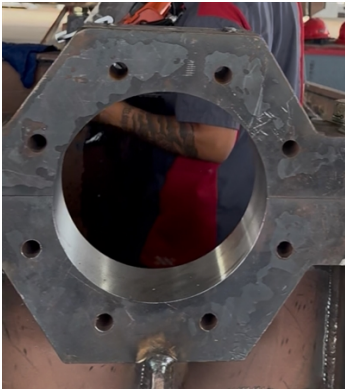
Customer had bored 1-1/2" holes when 5/8" was needed for bearing housing.

Pillow block with oversized bolt holes.

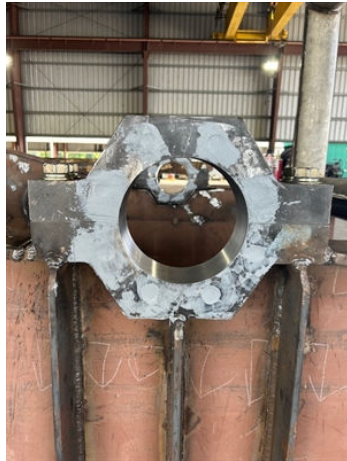
Holes filled with Belzona 1161 by injection.

Surface prep was conducted using a pencil grinder and cleaned with Belzona 9111. Afterwards, Belzona 1161 was injected into holes using a mixing board as back stop and touched up after sliding mixing board off. Holes were bored to appropriate size through Belzona 1161 to allow bearings to be installed.

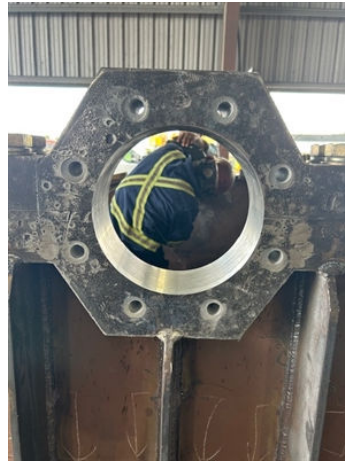
Holes bored to correct size through the Belzona 1161.

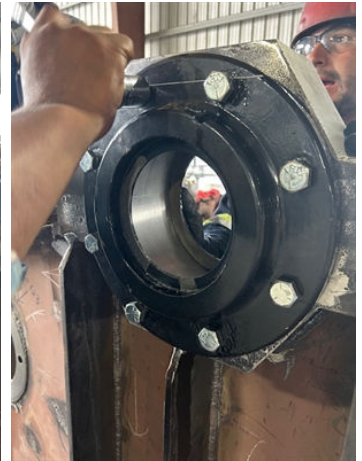
Bearing casing fit-tested for installation.
