# Belzona Elastomers Save the Day on this Crane Track Repair

ID: 9931

Industry: Mining & Quarrying  
Application: SHM-Solids Handling Machinery

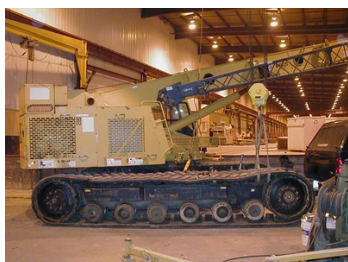
The rubber track for this crane was almost cut in half

Crane

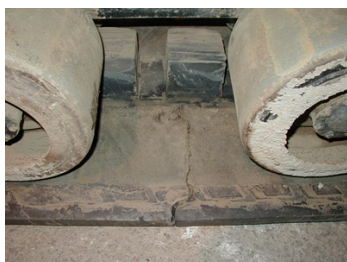
Close up of the damaged rubber track of a crane

A grinder was used to prepare the substrate. Belzona 2911 (QD Conditioner) was applied to the prepared area.

A grinder was used to prepare the substrate. Belzona 2911 (QD Conditioner) was applied to the prepared area followed by a skim coat of Belzona 2221 (MP Fluid Elastomer). The area was then built up with Belzona 2211 (MP Hi-Build Elastomer). This was returned to service the following day.
