Valve Body Assembly protected with Belzona

ID: 9935

Application: CEP-Centrifugal Pumps

Application Date: July 2018

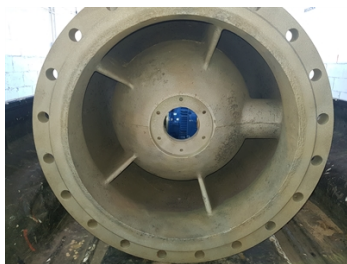
The valve assembly had damage on it from erosion of years of use in the water industry. Most of the machine surfaces had to be repaired using Belzona.

Valve body assembly arriving for preparation and application

The internal surfaces were abrasive blasted to obtain a clean and rough surface with an anchor profile of approximately 3 mils. A chloride contamination test was performed after blasting to confirm surface suitability. Degreasing was then carried out using Belzona 9111. Areas with visible metal loss or damage were rebuilt using Belzona 1111 (Super Metal). After the rebuilding process, Belzona 1321 (Ceramic S-Metal) was applied in two coats, grey followed by blue, to ensure full coverage and long-term corrosion protection.

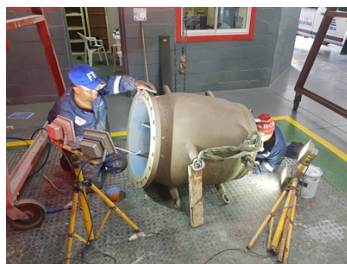
First coat of Belzona 1321 being applied

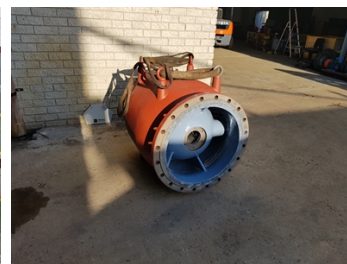
Valve body assembly done

The customer was evaluating a costly replacement of a valve assembly. By selecting the Belzona solution, they avoided extended downtime and significant capital expenditure. The application was performed at the local Belzona Workshop, restoring structural integrity and providing long-term corrosion protection at a fraction of the cost of replacement.
