Overhead repairs to spalled balconies

ID: 9939

Customer Location: Retford

Application Date: June 2024

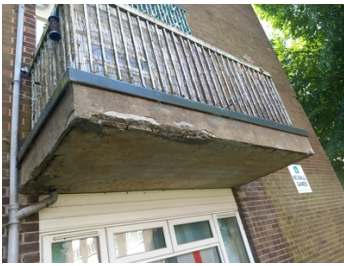
A number of balconies had started to spall and were listed as dangerous, needing urgent attention

Badly spalled concrete to under-ledge of balcony

Break off any loose and friable faulty, spalled concrete

Wire brush all exposed repair back to clean steel

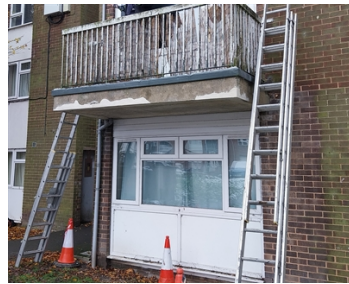
Work in progress

Mix and apply Belzona 4911 to the target areas with a short bristled brush

Mix and apply Belzona 4141 to target areas using a board, coated with Belzona 9411 release agent, as a straight edge

Compress and smooth using a finishing trowel

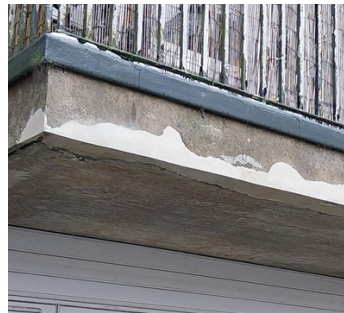
18 months on, the repairs are still in perfect condition

Belzona was employed as the repair material and no further action has been necessary

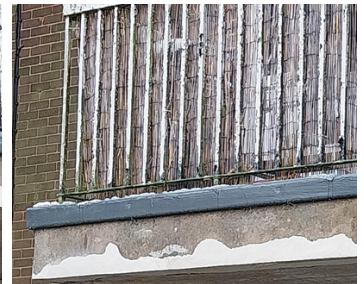
A further angle, showing 1 of 20 successful concrete repairs, some 18 months later
