Belzona repairs underfloor cast church water pipe

ID: 9940

Application: VPF-Valves, Pipes and Fittings

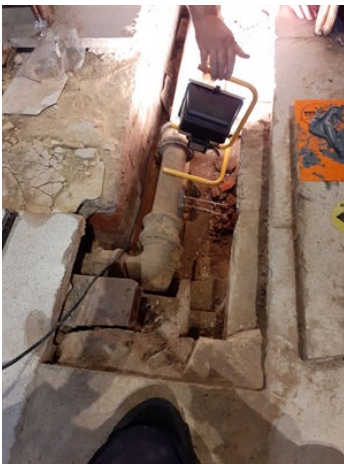
The pipes under the floor, now isolated and the water removed. The leak was still weeping

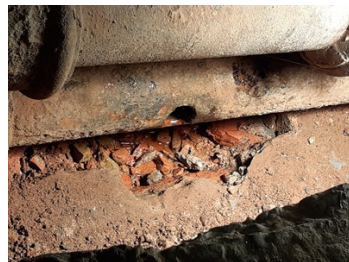
Water was accumulating on the church floor, which appeared to be emanating from under the floor itself. The floor was lifted and a large hole was identified in the cast iron mains water pipe.

The throughwall was identified as a large hole in the side of the main 4" pipe
