Boiler house sump given new life

ID: 9941

Industry: Chemical & Petrochemical
 Application: TCC-Tanks and Chemical Containment Areas
 Substrate: Concrete
 Products: Belzona 1391T

Customer Location: Derby
 Application Date: June 2021

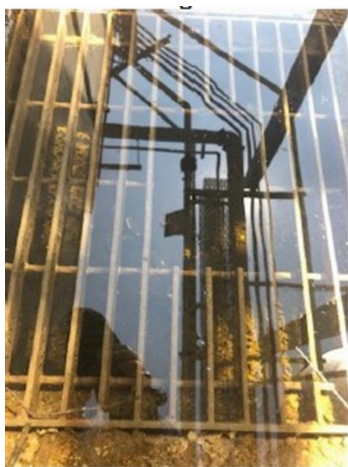
Sump in use, requiring emptying

Remove old coating and effect any necessary concrete repairs

Prepare all surfaces by blast cleaning

Mix and apply the 1391T as per the IFU

Apply 2 x coats as per 1391T IFU and post cure

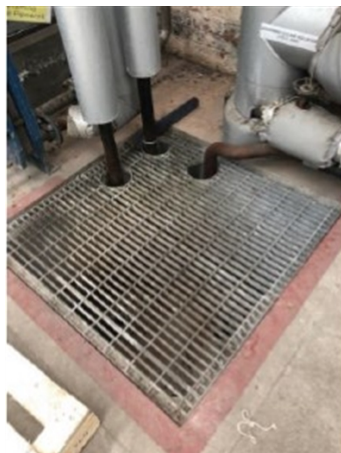
Sump cleared and awaiting inspection
