High Visibility Marking for fall Hazard

ID: 9942

Industry:	Water / Wastewater	Customer Location:	Victoria, BC
Application:	FPA-Floor Problem Areas	Application Date:	June 2025
Substrate:	Composite		
Products:	Belzona 5231 (SG Laminate), Belzona 9231 (Surefoot Aggregate)

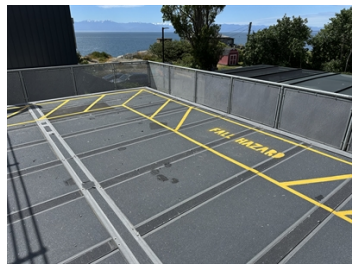
High visibility markings identifying fall hazard

The areas were masked off in neat and tidy lines and a template was made indicating 'FALL HAZARD' as specified by the safety teams. Belzona 5231 was applied by brush and roller and Belzona 9231 Surefoot Aggregate was broadcasted to rejection. A final coat of Belzona 5231 was applied as a top coat.

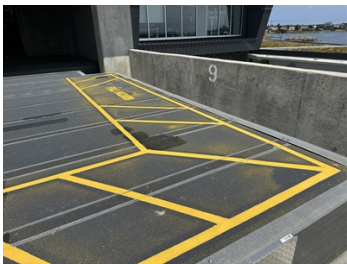
Clean lines, 3 coats total were applied

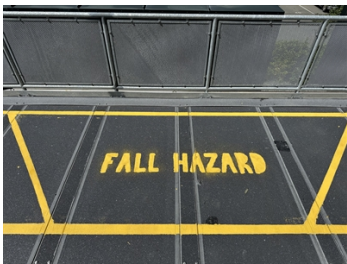
Text application using custom stencil

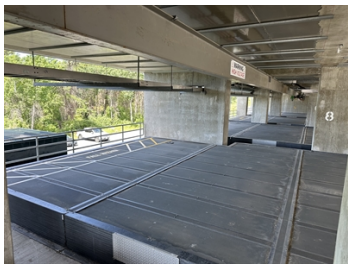
A total 7 tank lids were completed
