Concrete repairs to food factory

ID: 9944

Application: FPA-Floor Problem Areas

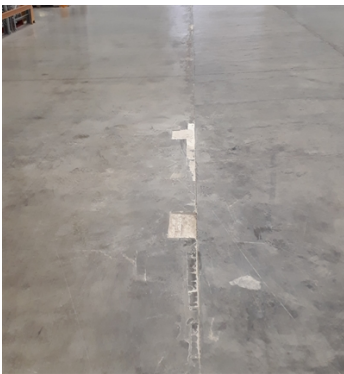
Various cracks and damage had been identified which caused issues for the hard-wheeled fork lift trucks and hand pallet trucks losing their loads

A general area to repair (Area 1)

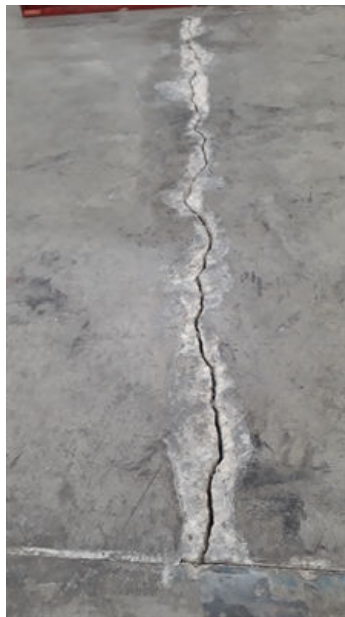
Cracks, showing prep to sides and solid surrounding substrate

Break away any loose and friable.

The client's team had actually saw cut some of the areas, which, whilst not normally necessary, made little difference to the application

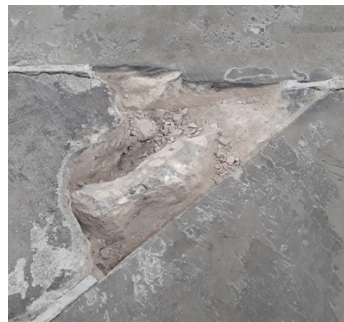
Further damage to adjacent slabs, causing issues for FLT Traffic

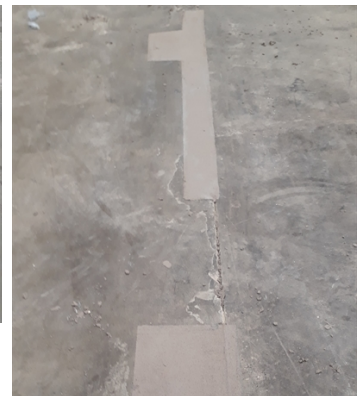
Area 1 fully repaired and checked on some 5 years after, still in place, still performing

5 Years later, the repair is still performing with no signs of damage

Belzona 4911 was mixed and applied using a short bristled brush

Belzona 4131 was mixed as per the IFU and applied to the problem areas

The Belzona 4131 was compressed and dressed using a finishing trowel
