Concrete repairs to food factory

Application: FPA-Floor Problem Areas

Substrate: Concrete

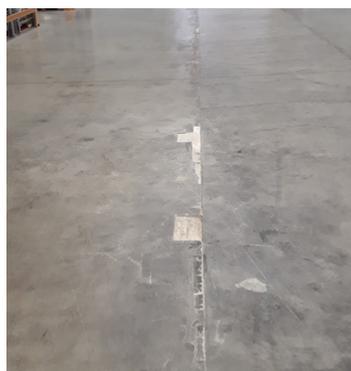
A general area to repair (Area 1)

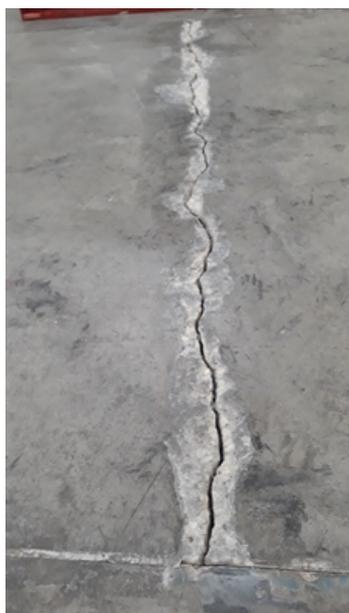
Cracks, showing prep to sides and solid surrounding substrate

Break away any loose and friable.

The client's team had actually saw cut some of the areas, which, whilst not normally necessary, made little difference to the application

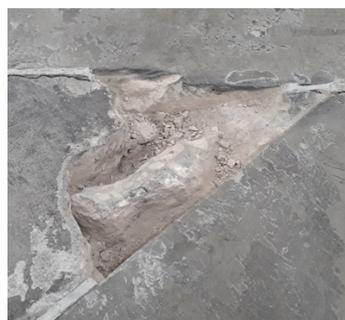
Further damage to adjacent slabs, causing issues for FLT Traffic

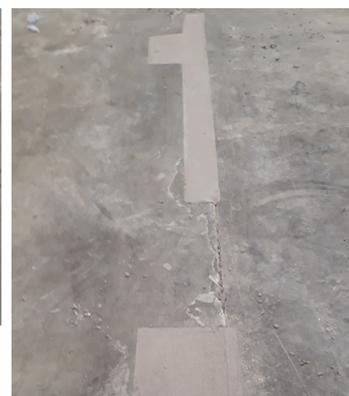
Area 1 fully repaired and checked on some 5 years after, still in place, still performing

5 Years later, the repair is still performing with no signs of damage

Belzona 4911 was mixed and applied using a short bristled brush

Belzona 4131 was mixed as per the IFU and applied to the problem areas

The Belzona 4131 was compressed and dressed using a finishing trowel
