Mixed chemical sump leaking into water table - SAVED

Application: TCC-Tanks and Chemical Containment Areas

Substrate: Concrete

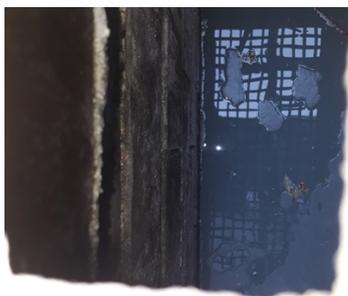
A trough handling spillage from a line of 10 chemical tanks would empty into a sump, creating a cocktail of various harsh chemicals. The sump was found to be leaking and urgent action was needed to contain and properly manage the waste.

Showing damaged sump with little in the bottom, following further leakage

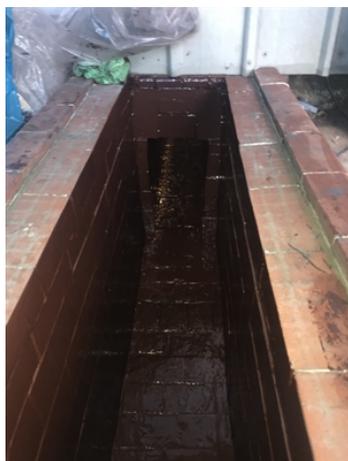
The trough completely lined and sealed

The trough had to be temporarily sealed to ensure that no further chemicals entered the working area of the trough end and the sump. The client could only find Belzona to offer a coating that would perform with such a mixture and cocktail of chemicals, these being Caustic Soda(Sodium Hydroxide) @ 29%-51%

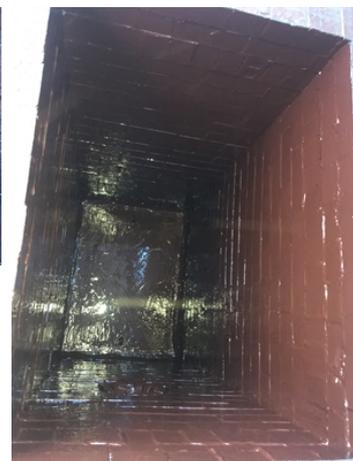
A steel plate was employed to seal over the damaged floor, this was grouted in with Belzona 4311 CR1 prior to encapsulating the whole sump

The sump with a new base plate, completely encapsulated

Fit new base plate and flaunch in with Belzona 4311

Mix and apply Belzona 4911 (Magma TX) to the prepared area of the bund.

Mix and apply Belzona 4181 (AHR Magma Quartz) to the already conditioned areas at a minimum of 3mm.
