Mixed chemical sump leaking into water table - SAVED

ID: 9945

Application: TCC-Tanks and Chemical Containment Areas

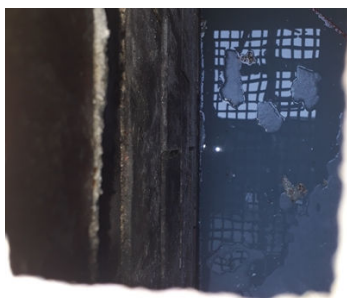
Showing damaged sump with little in the bottom, following further leakage

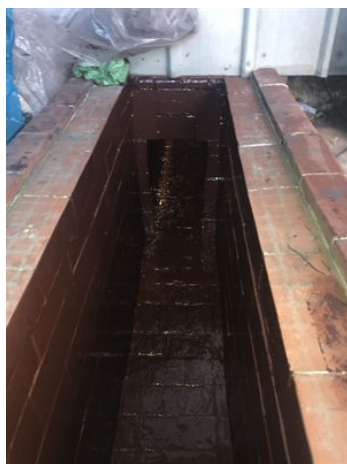
The trough completely lined and sealed

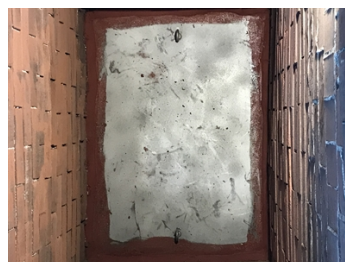
A steel plate was employed to seal over the damaged floor, this was grouted in with Belzona 4311 CR1 prior to encapsulating the whole sump

Fit new base plate and launch in with Belzona 4311

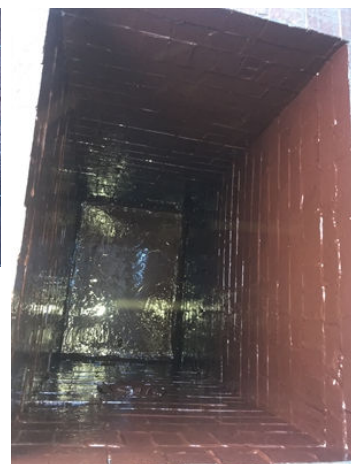
The sump with a new base plate, completely encapsulated
