# Belzona protects Containment Area in a Wastewater plant

ID: 9947

Industry: Water / Wastewater  
Application: TCC-Tanks and Chemical Containment Areas  
Substrate: Concrete  
Products: Belzona 5815

Customer Location: Victoria, BC  
Application Date: June 2025

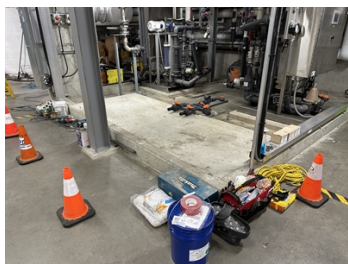
A recent leak in the containment area had water penetrating through cracks in the concrete into an electrical room below.

Photo of containment area with storage tanks removed

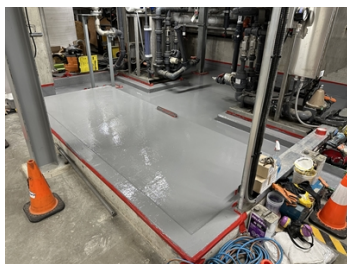
Application in progress

The concrete was ground using diamond cup grinders with hepa-vac systems. Two coats of Belzona 5815 were applied by brush & roller.

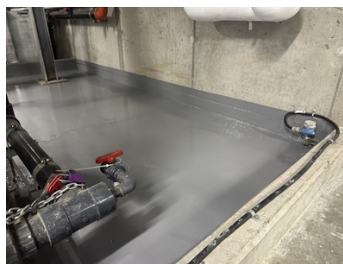
View of containment area

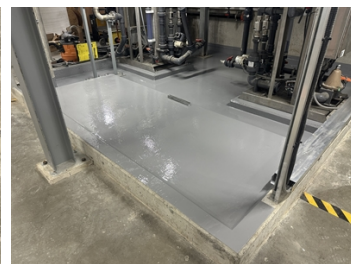
Finished application
