# Belzona solution for failed expansion joints

ID: 9951

Industry: Buildings & Structures  
Application: FPA-Floor Problem Areas  
Substrate: Concrete  
Products: Belzona 4521 (Magma-Flex Fluid), Belzona 4911 (Magma TX Conditioner)

Customer Location: Worksop  
Application Date: April 2019

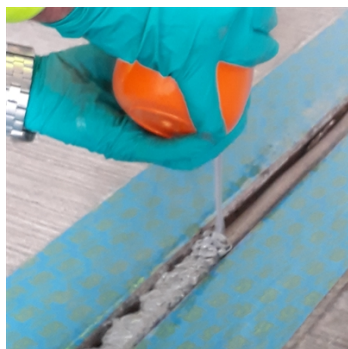
Joint prepared and 4521 being applied

Belzona 4911 was applied to all target areas

The Belzona 4521 was mixed and applied in accordance with the IFU

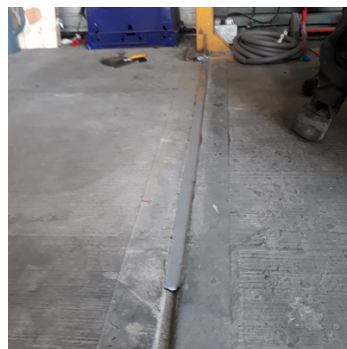
Pouring in the Belzona 4521

This was then poured into the joint, smoothed over, masking removed and left to cure

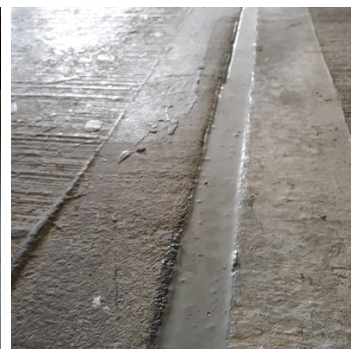
Completed works showing the Belzona 4521 still in it's intended location

The Belzona 4521 held it's place, giving it ample time to cure, giving a long lasting and robust solution
